Manhole Inspection Summary

Manhole # S41WW_021MH

Insp Date: **4/12/07 12:48 PM**

Location Address: **3220 LOCH RAVEN BLVD** Cross Street: **GORSUCH AVE**

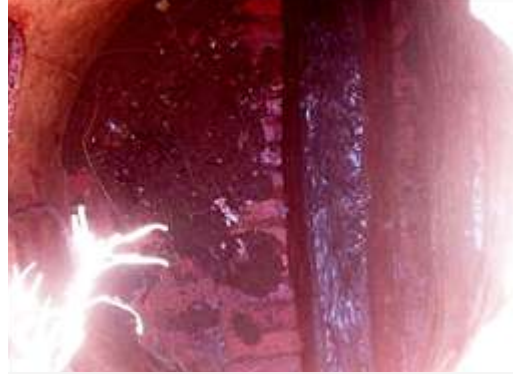
Top View

Corroded steps. Evidence of surcharge - Bench debris.

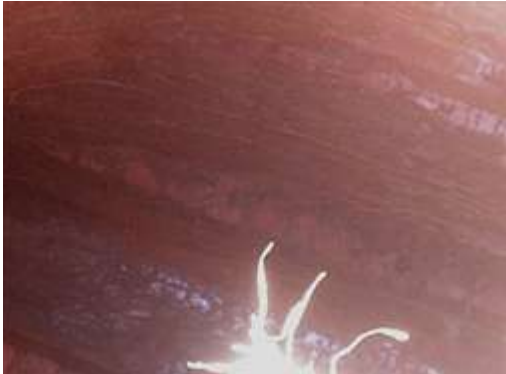
Defect

Barrel root intrusion and infiltration.

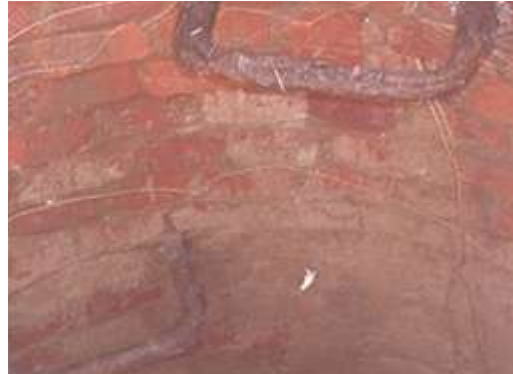
Defect

Corbel root intrusion and infiltration. Barrel infiltration.

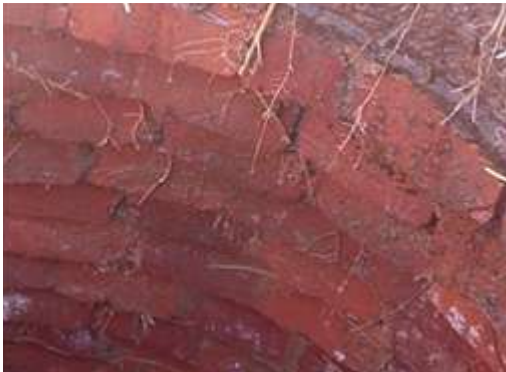
Defect

Frame leaks. Adjustment deterioration, root intrusion and infiltration. Corbel root intrusion and infiltration.

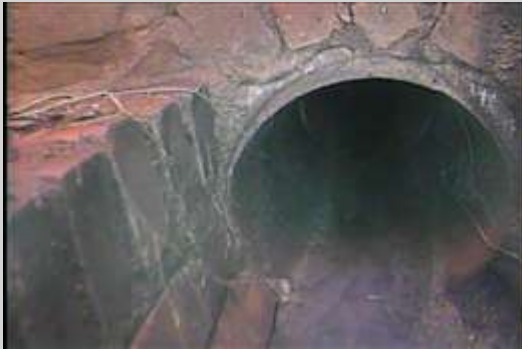
10 in. Circular Gravity Sewer Pipe Out @ 12 O'Clock

Channel deterioration. Bench root intrusion.

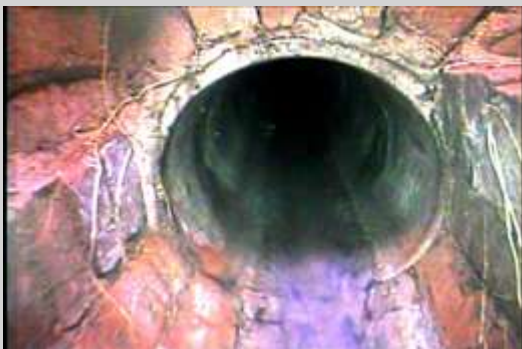
10 in. Circular Gravity Sewer Pipe In @ 6 O'Clock

Channel deterioration and root intrusion.

Infiltration: **Evidence** Pipe Seal Cond: **Roots**
